Weston Solutions, Inc.
7800 West Outer Drive
Suite 200
Detroit, MI 48235
Phone: (313) 739-2533

September 25, 2009

**Subject: Site Assessment Letter Report
Westover Landfill Site
Oregon, Lucas County, Ohio
Technical Direction Document No.: S05-001-0906-025
Document Control No.: 680-2A-AETT
Work Order No.: 20405.012.001.0680.00**

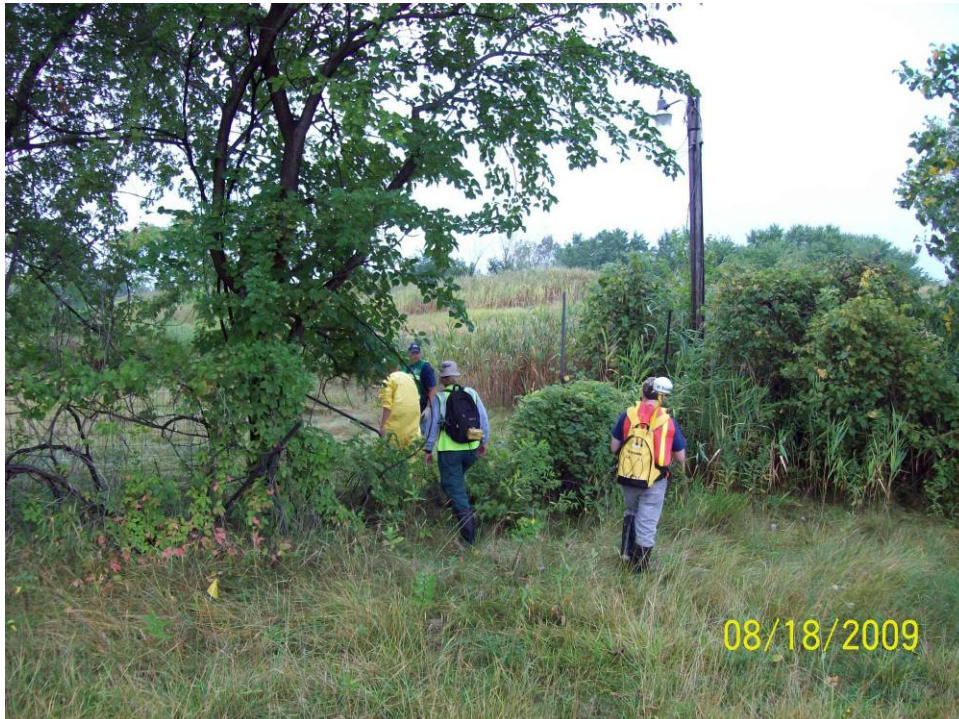
Photo Number: 002

Subject: Trees growing on the landfill cap, north end of the Site

- Removal and disposal of all trees and invasive phragmites vegetation from the landfill cap, and reseeded with appropriate cap vegetation;
- Reinforcement or replacement of the leaking plug in the storm water outfall pipe at the northwest corner of the Site to halt the chronic discharge of leachate-contaminated water to Otter Creek and prevent a complete failure of the plug;

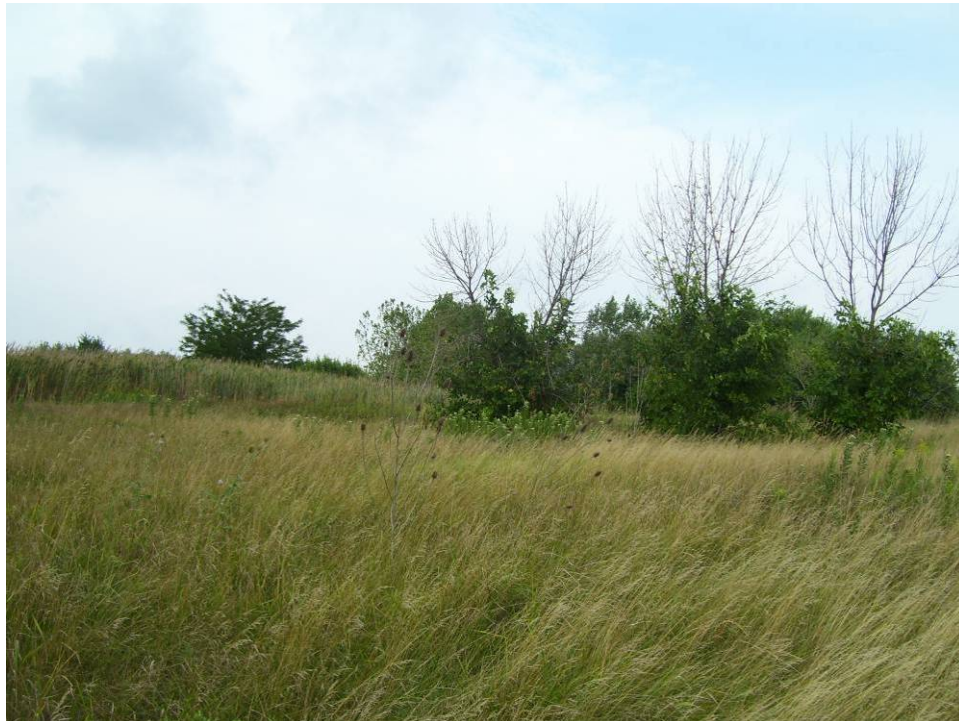
Photo Number: 004

Subject: Trees growing on the landfill cap, north end of the Site

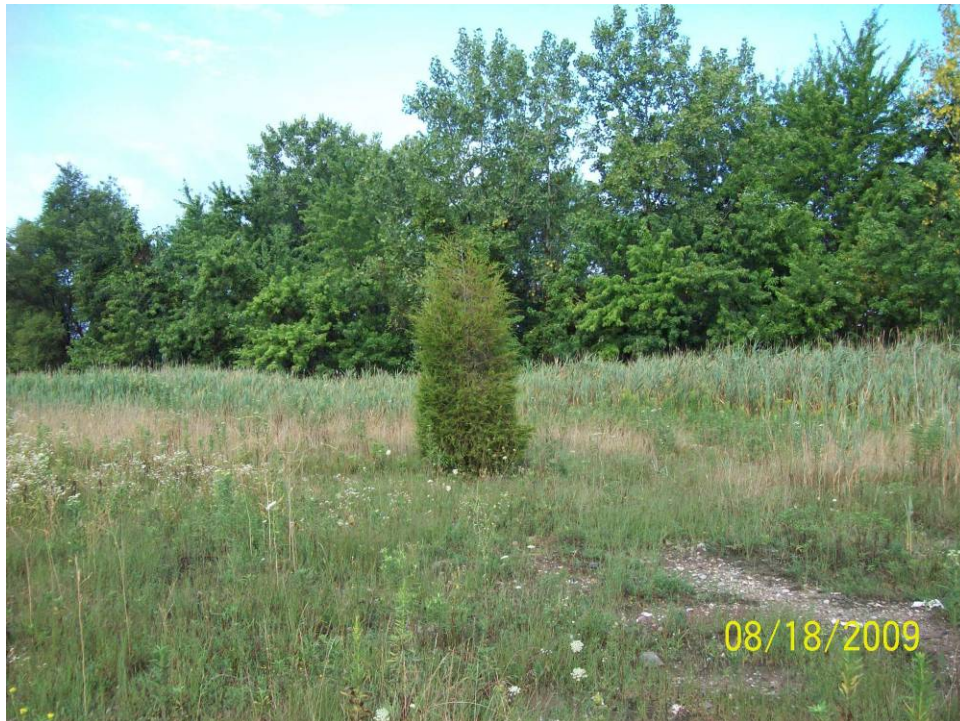
Photo Number: 006

Subject: Trees growing on the landfill cap, west side of the Site

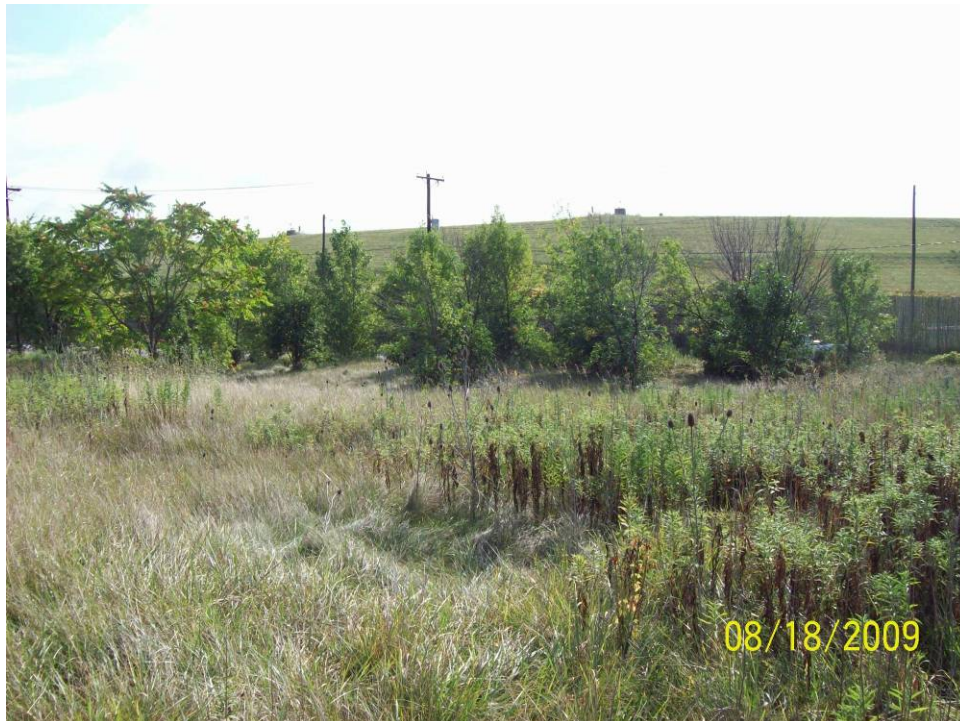
Photo Number: 008

Subject: Distressed vegetation and washout on the landfill cap, west side of the Site

- Improvements to the clay cap and existing storm water control structures to reduce leachate outbreaks at the surface and prevent infiltration into the storm water control system and Otter Creek;

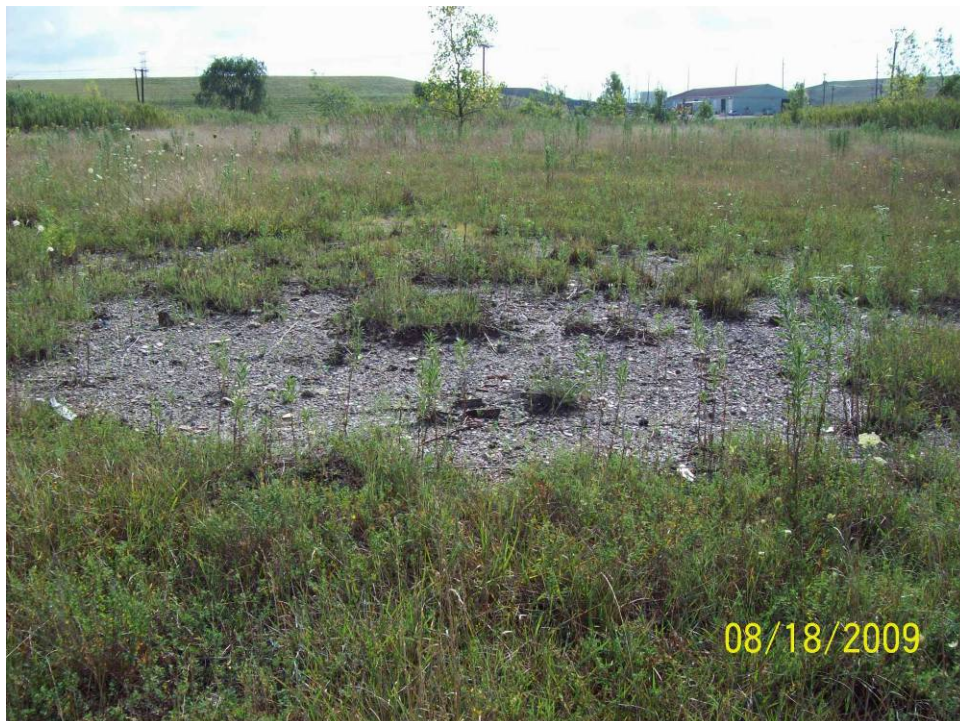
Photo Number: 010

Subject: Distressed vegetation and washout on landfill cap, west side of the Site

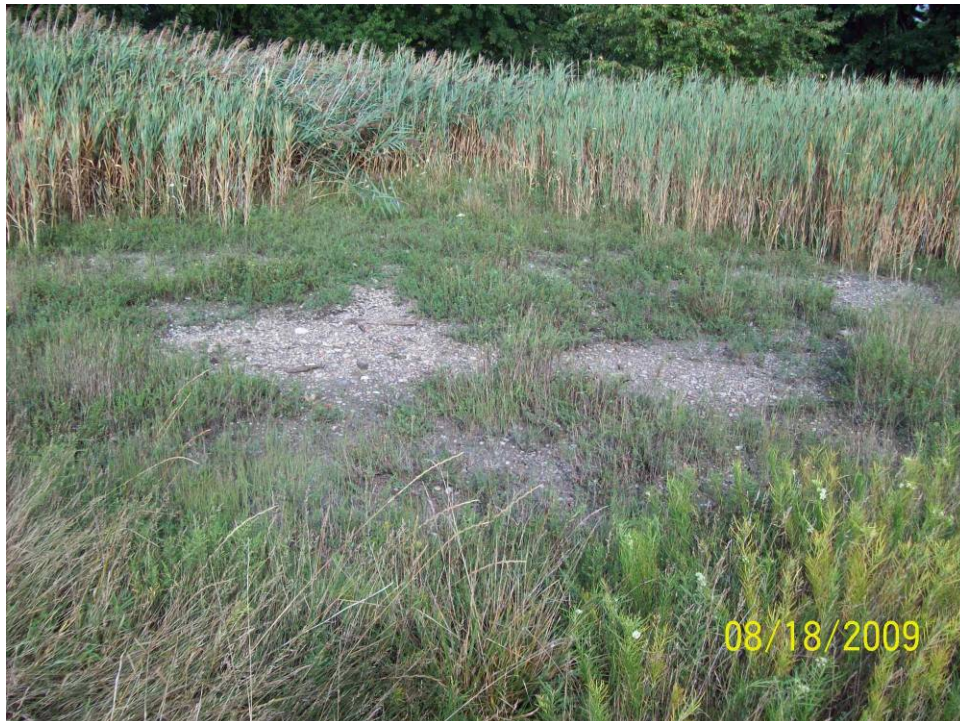
Photo Number: 012

Subject: Deer tracks inside the landfill fence line, west side of the Site

- Improvements to the restriction of site access including replacement or repair of damaged or missing portions of the perimeter fencing;
- Removal and disposal of excess liquid wastes from the perimeter leachate collection system;

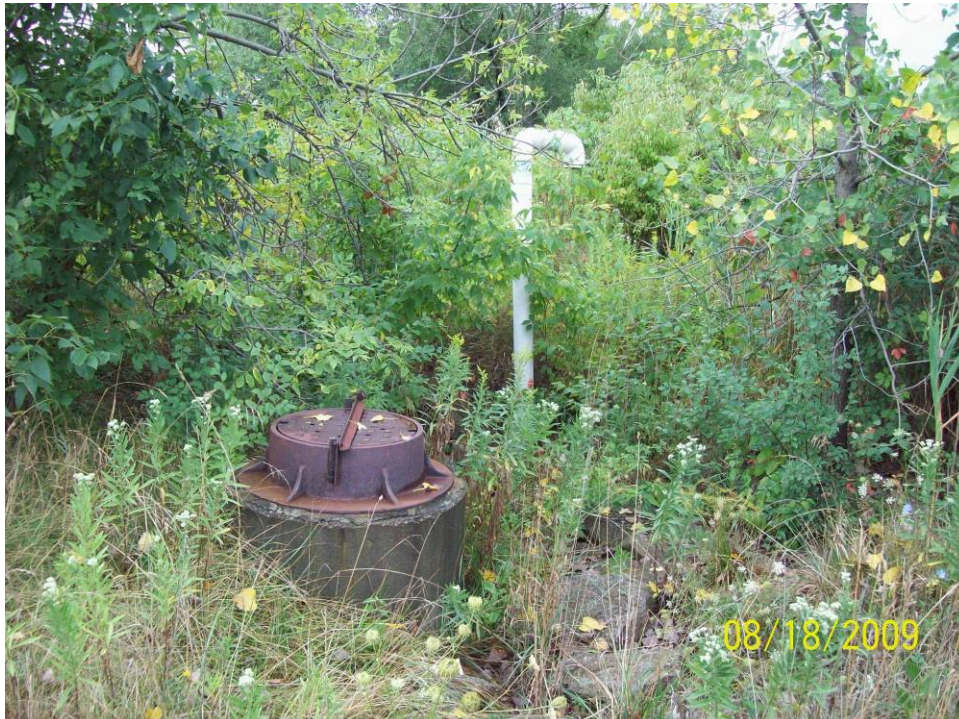
Photo Number: 023

Subject: Broken PVC pipe beneath concrete debris, located near the leachate collection manhole and gas vent at the southeast corner of the Site

- Improvements to the leachate collection system to repair damaged PVC components at the southeast corner and western perimeter;
